# Manhole Inspection Summary

Manhole # S29A\_\_034MH

Insp Date: **12/21/07 11:25 AM**

**Location** Address: **593 ORCHARD ST**

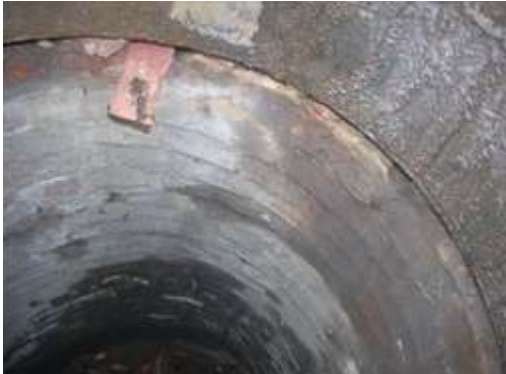
Defect 2

Infiltration: ☐ None ☐ Joint ☐ Cracks ☐ Mortar ☐ Roots ☒ **Wall**

BARREL INFILTRATION

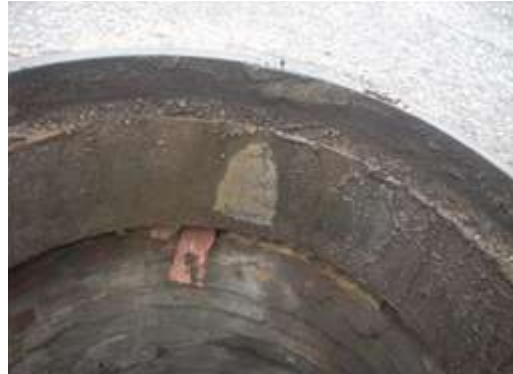
Defect 1

Condition: ☐ Sound ☐ Cracked ☐ Root Intrusion ☒ **Loose Brick** ☒ **Deteriorated**

LOOSE CHIMNEY BRICKS AND  
CHIMNEY DETERIORATION

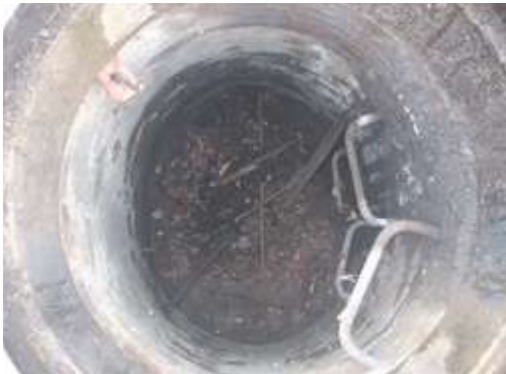
Defect 3

Condition: ☐ Sound ☐ Cracked ☐ Root Intrusion ☐ Deteriorated ☐ Leaks ☒ **Debris**

CHANNEL DEBRIS

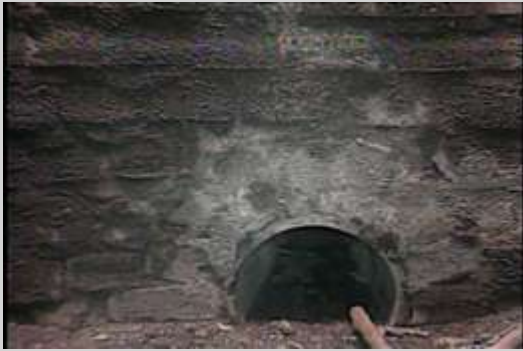
12 O'Clock Outflow

8 in. Circular Gravity Sewer  
Pipe Out @ 12 O'Clock

Deposits: ☐ None ☐ Mud ☐ Sludge ☒ **Debris** ☐ Grease

Silt Depth: **2** (in.) Deposits Extent: **Medium**
